EXCAVATION AND SEISMOLOGY

HONEYWELL, INCORPORATED

PREPARED FOR
ADVANCED RESEARCH PROJECTS AGENCY
BUREAU OF MINES

MAY 1974

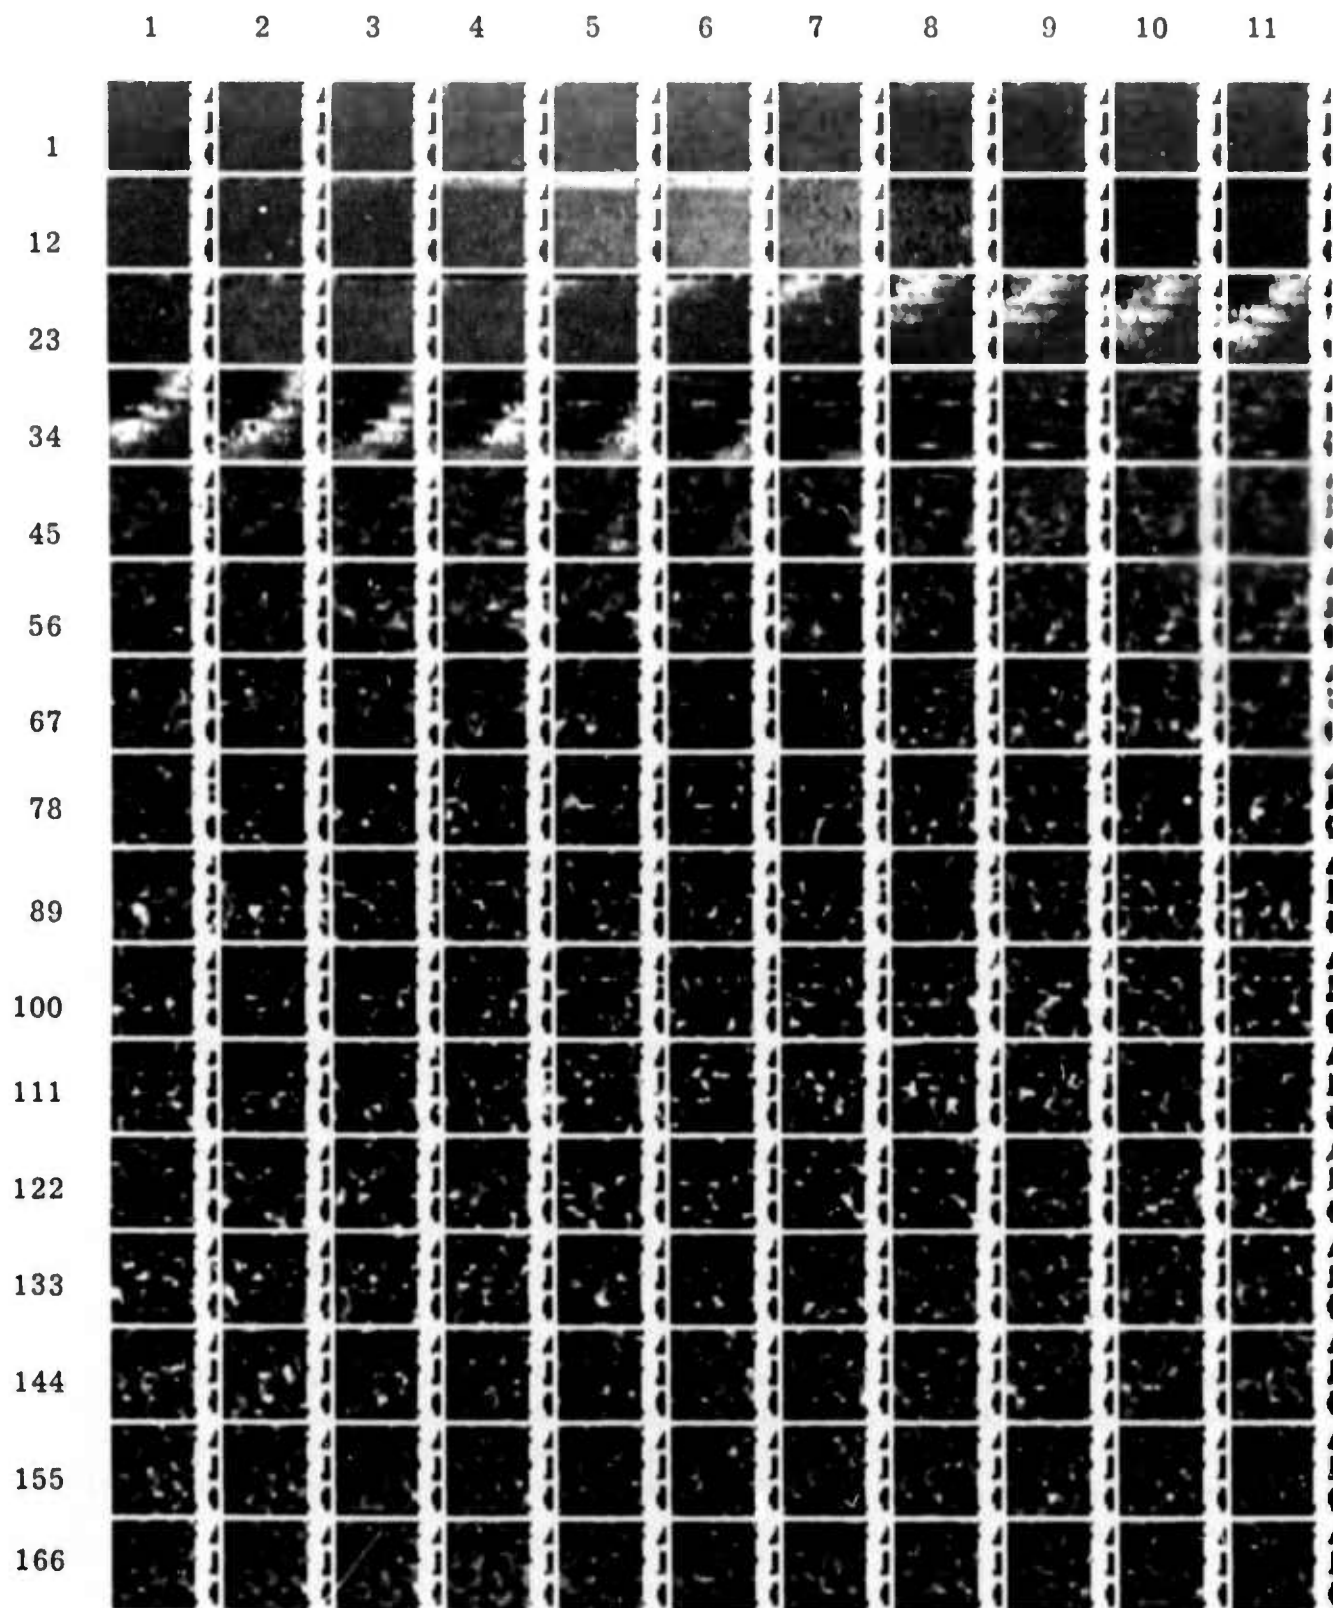
In the following discussion of Figure 19, the individual frames are numbered starting with number 1 in the upper left corner, number 11 in the upper right corner, number 12 below number 1, etc., to number 176 in the lower right corner. Rows are numbered 1 to 16 from top to bottom. Each of the 176 frames is an array of .4 mm x .4 mm squares (pixels). Each frame is 29 pixels high and 28 pixels wide. In scanning the original

Figure 19. Movie of Frame 16 Showing Direct and Reflected Waves.
(Movie frames read left to right starting at the top row.
Frame interval is .014 milliseconds.)

photograph with a .1 mm aperture, each band (15 lines) produced 28 samples. Since there were 15 bands, the natural movie frame format would be 28 x 15 pixels. Because of the slight overlap between adjacent lines on the original picture, this format looked fuzzy in the horizontal direction (due to the averaging effect of the overlap), but was very sharp vertically. The net effect was that of extreme astigmatism and was very uncomfortable to view. To counter this, an extra pixel row was placed between each two original rows. This extra row was generated by averaging the intensities of the two rows. This makes the frame equally fuzzy in both directions and thus easier to look at.

This says that the reflected p-wave arrives first at 15, 15 and moves toward 1, 1--opposite to the observed wave in Figure 19. The reflected s-wave moves in the correct direction, but it arrives too late and moves too fast to agree with Figure 19.

Based on these two tests (direction of travel and perpendicular distance), the obvious choice for the identity of the wave in row 5 of Figure 19 is a shear wave.

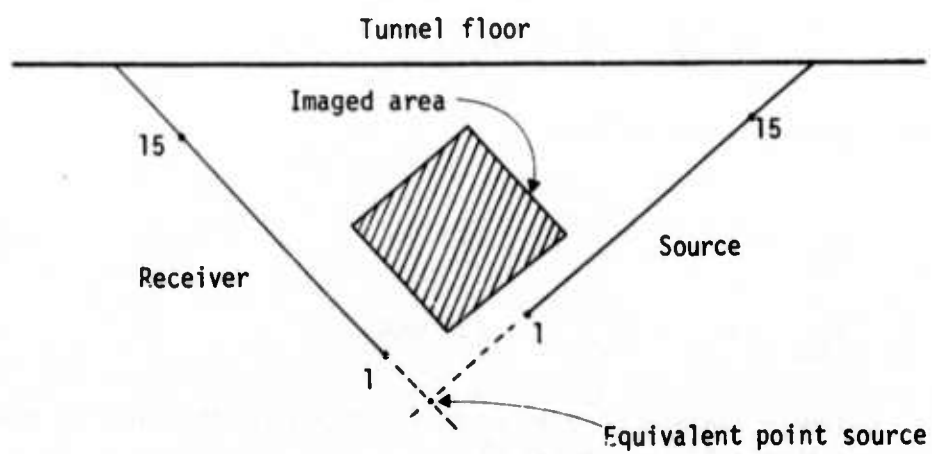
Figure 20. Image Area and Point Source Relative to Test Holes.

We can easily eliminate reflections from the surface by the direction of travel. The upper left corner of each frame corresponds roughly to the location of the equivalent point sound source. The rock surface is beyond the lower right corner. Figure 20 illustrates this. The upper left corner of each frame corresponds to source position 1 and receiver position 1. In the figure, this is at the midpoint of the line connecting source 1 to receiver 1. The shaded area is the equivalent image area corresponding to the frames, and the equivalent point source is at the intersection of the two lines. Thus a surface reflection would appear to propagate in the opposite direction to a direct wave.
